Condition Assessment of Wood

Robert J. Ross, Ph.D.

USDA Forest Products Laboratory
Madison, WI

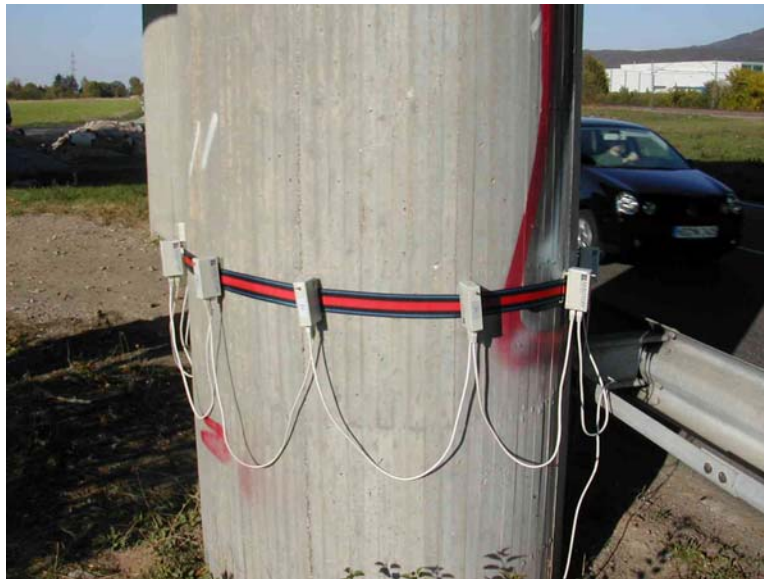
Arbotom[®] at concrete = PICOTOM

Testing of new and old concrete, steel and compound structures in order to find cracks and other signals of beginning or further decay. The stress wave speed was shown to be a significant measure for identifying damages even in early stages – on a non-destructive way.

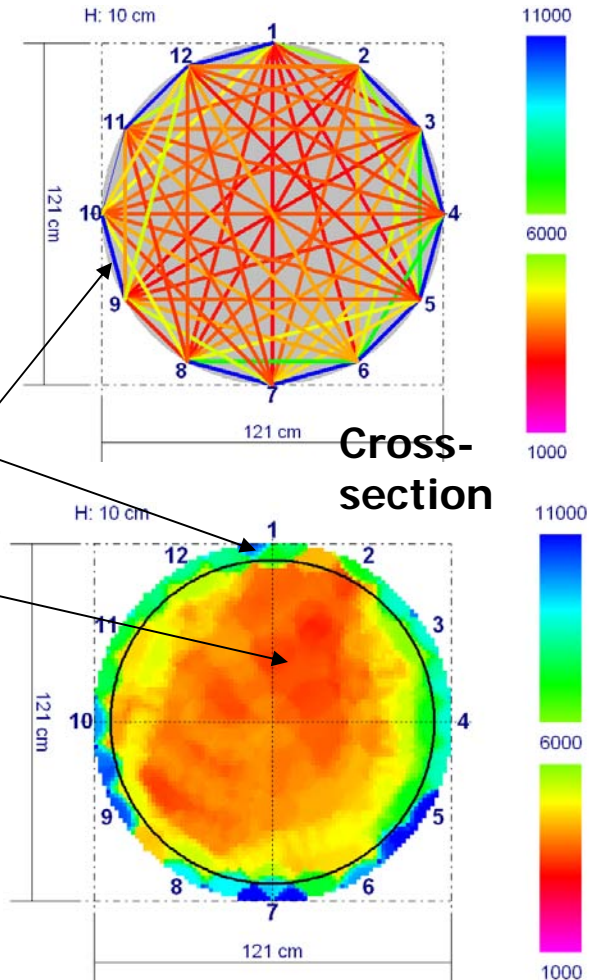
Strong shell
but missing
connection to
the weak
central part.

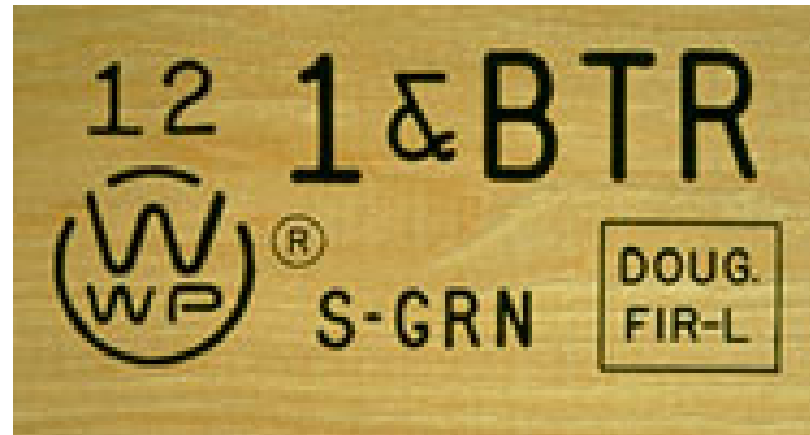
Quality – Grade level

- Grading Rules
 - Visual grading rules
 - Machine grade or product stamps
- Visual Characteristics
 - Knots
 - Slope of grain
 - Warp
 - Check/split
 - Decay

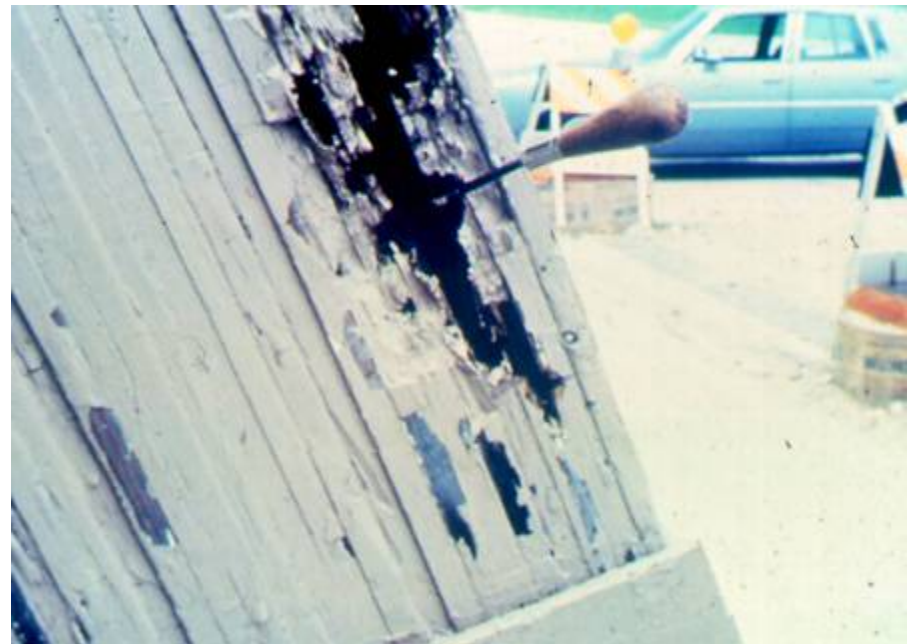
Probing

- Use an awl or knife to probe areas of suspected decay or insect damage
 - A splintered break reveals sound wood
 - A brash break indicates decayed wood
 - Use caution on water softened versus decayed wood

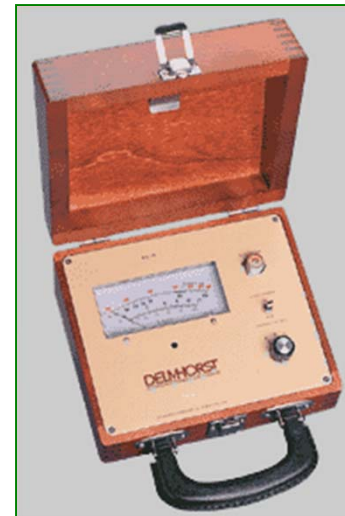
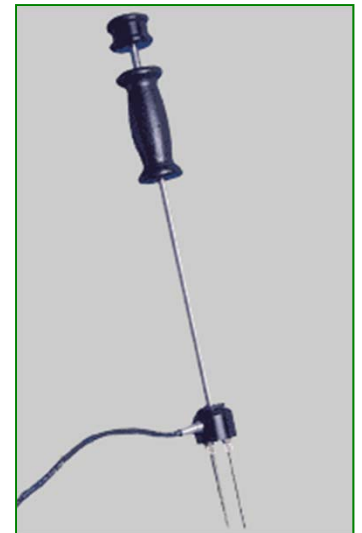
Moisture Meter

- Moisture content is indicative of the potential for decay
- Recommended as an initial check
- Sound wood
 - Interior moisture content 6-12%
 - Exterior moisture content 10-20%
- Potentially decayed wood
 - Moisture content (20-30%)

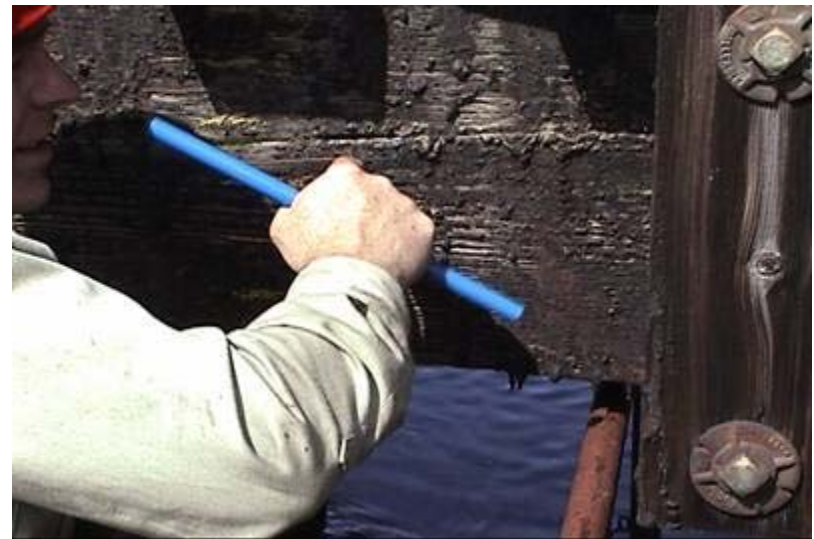
Coring

- Use a forestry increment borer
 - Determine voids
 - Allows for analysis of the core sample for presence of decay
 - Potential species ID
 - Determine preservative penetration
- Replug with treated wood dowel

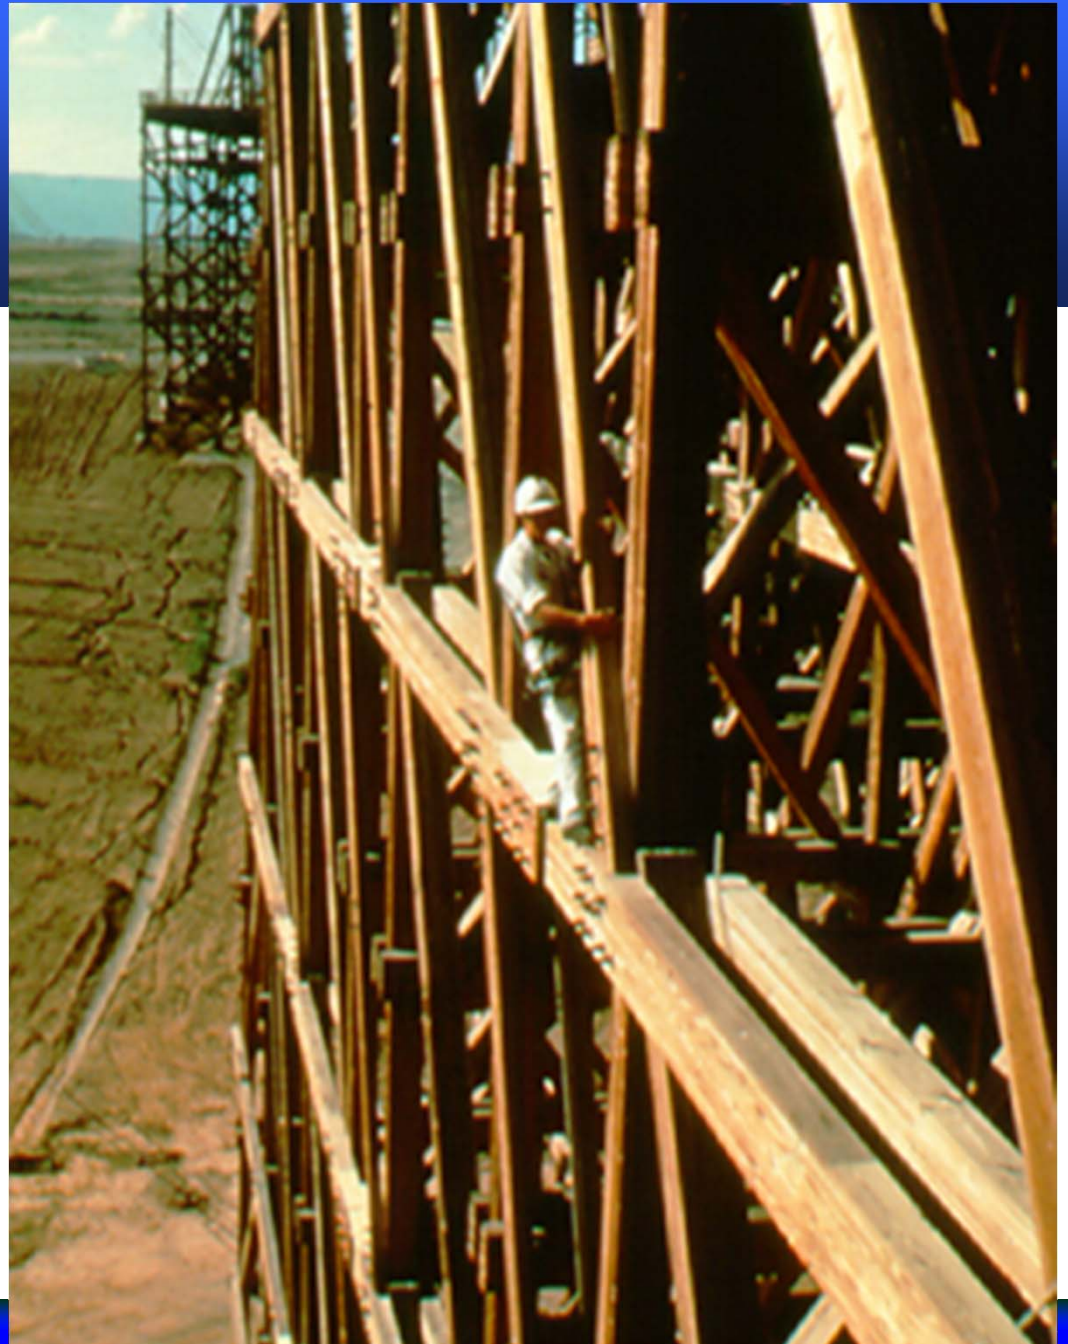
484 glulam
members
tested
(5% of the total
structural
members)

- The structural framework of TRESTLE showed only slight decrease in rated strength
- The exposed deck system was degraded 18 percent below the average of the structural framework members

- Replacement of some decking material
- OK to increase loads to accommodate alternate aircraft

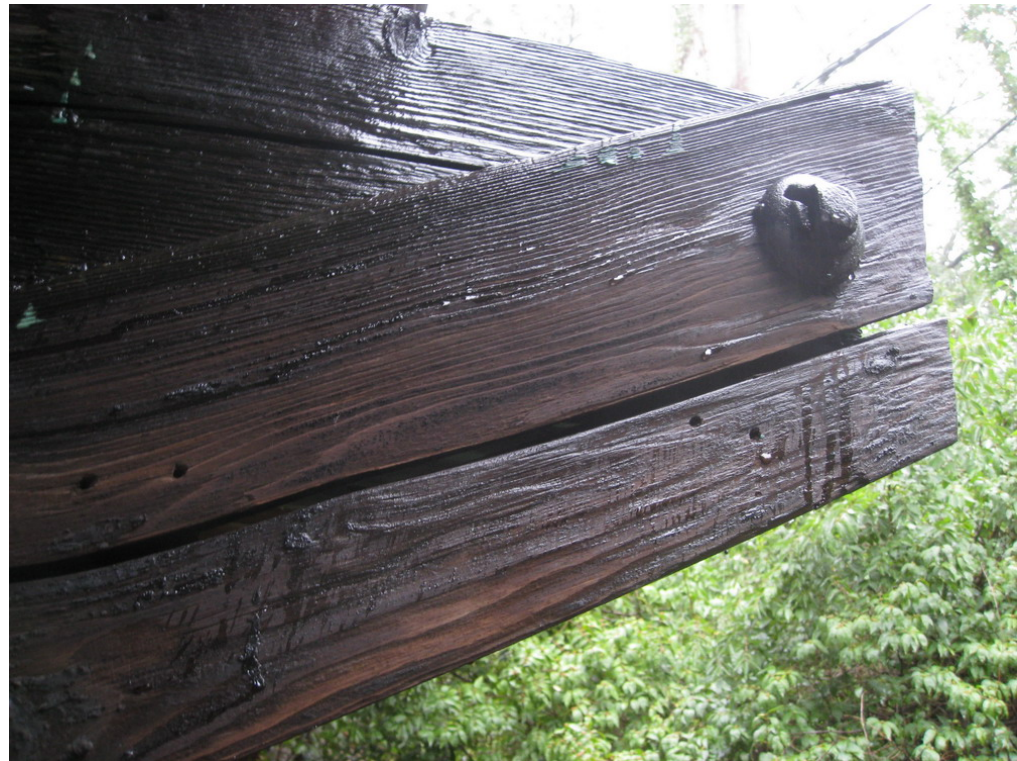
Deficiency of connection

- End splitting propagated through the connection region and compromises the integrity of the connection.
